# Kilcummin Church and Graveyard, Oughterard, Co. Galway: Conservation Management Plan 2025–2035

Prepared for Oughterard Culture & Heritage Group

By Ciara O'Flynn, Dr Fergal Donoghue, Chris Southgate & Ruth Minogue

November 2025

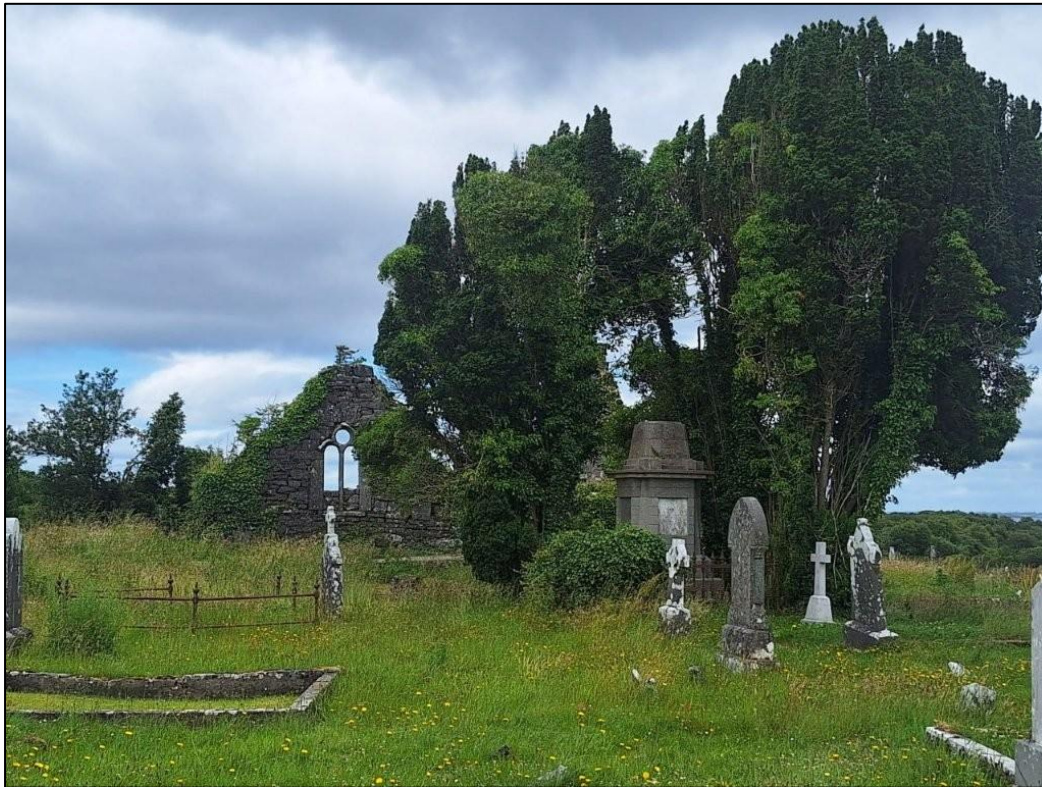
Plate 3 Approach showing south transept gable access is difficult and will require clearing

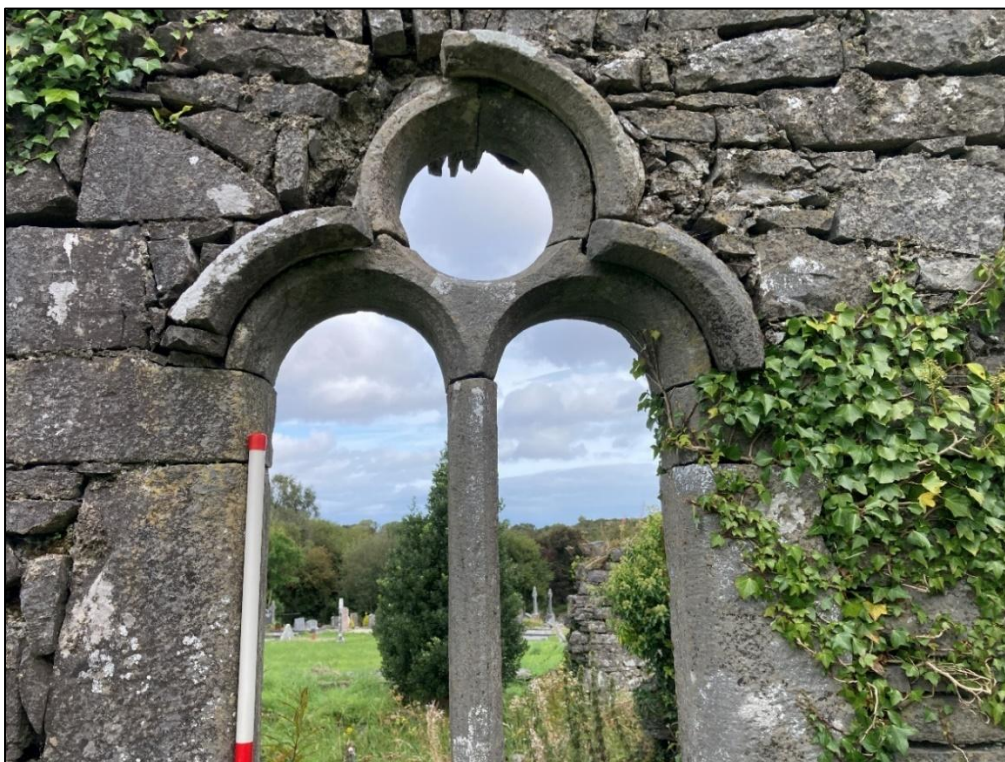
The transept was lit by a twin, round-headed light window with circular overhead in the south wall and is one of the primary remaining features of the church (Plate 7 and Plate 8). This round-headed window has a tri-partite, finely carved limestone hood-moulding with chamfered edges and is mostly intact with one upper section missing. It is thirteenth/fourteenth century in style. Internally the window opening is splayed with a square head reveal. The internal lintel (presumably stone given the survival of its equivalent on the east elevation) has been lost. A relieving arch above the lintel is of vertically placed limestone and the stone is carved to a fine, flat finish. The lower sections of this window have been blocked up with rough-cut but flat faced masonry bedded in mortar and the central mullion is of a single piece of limestone, the cill is also of well carved limestone. The interior is overgrown with brambles making inspection of the window cill difficult.

Plate 8 Twin light, round-headed window with circular oversight and tri-partite carved limestone hood-moulding in the south elevation.

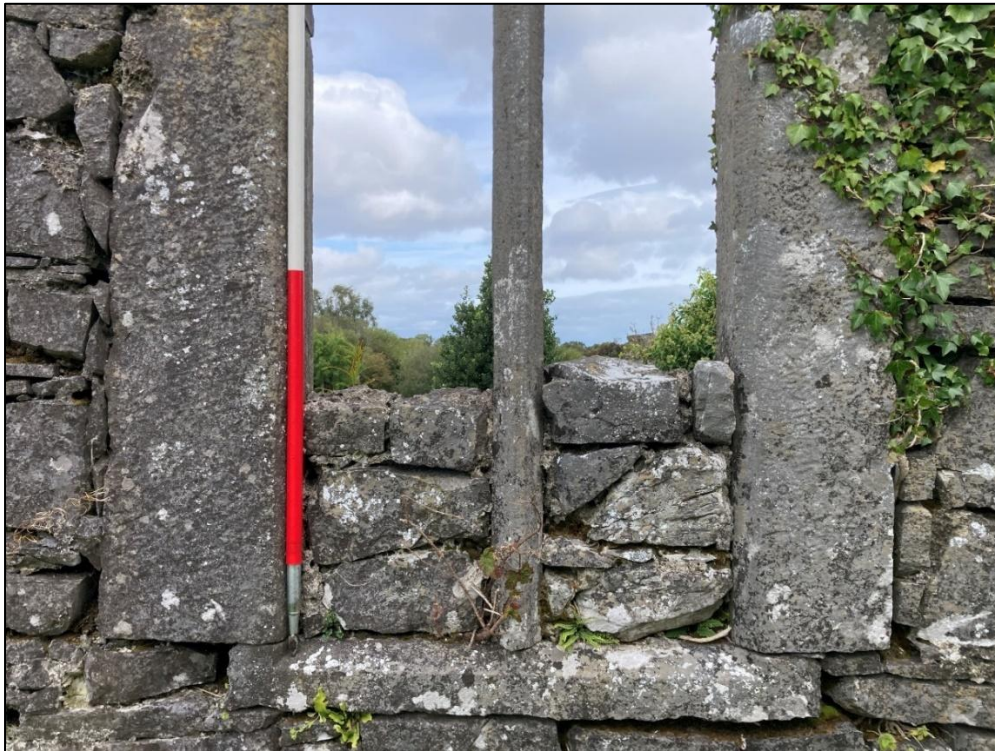
Plate 9 South elevation window partially blocked

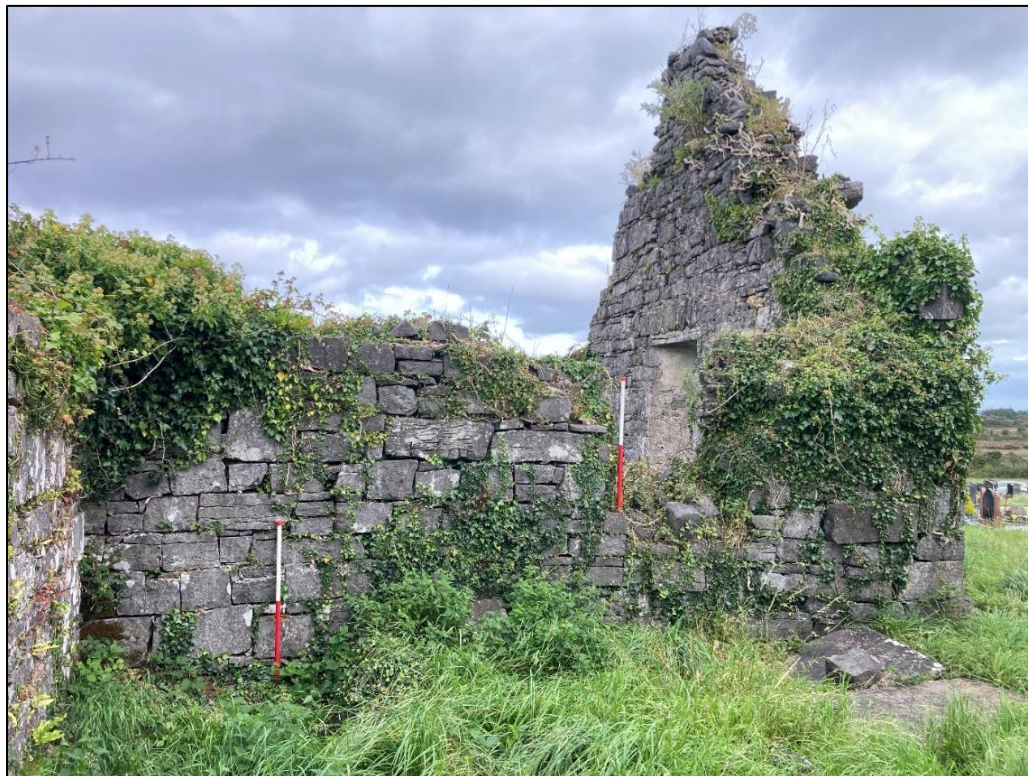
**Plate 14** South elevation showing fallen masonry

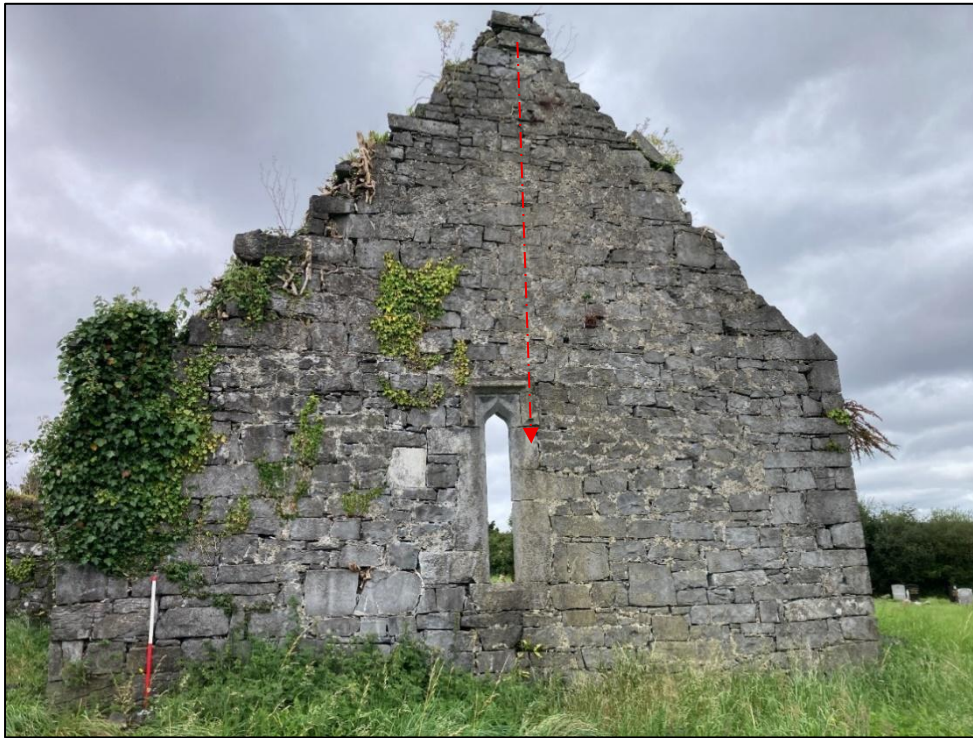
**Plate 17** View of the east elevation; note the off-centre single ogee-headed light which is centrally located when viewed from the interior. Ivy has been previously treated and is affecting wall tops and requires removal, treatment with eco plugs and pointing and grouting in phase 1

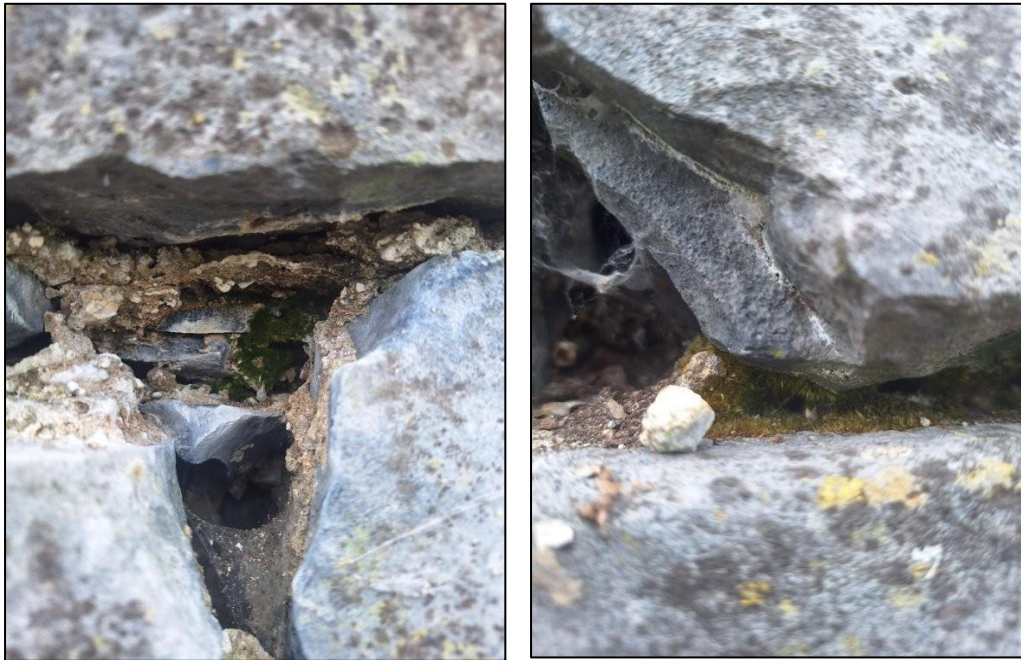
Visual inspection of the mortars has shown an unusually strong and structurally competent lime mix. This suggests that the ruinous condition of the church did not occur entirely from natural causes and may instead reflect deliberate destruction—potentially during the Reformation—or physical intervention. The mortar does not appear to have failed structurally, nor does it show signs of widespread erosion consistent with environmental decay.

Plate 19 Mortar was noted as competent and strong; while pointing is missing, the bedding mortar is solid.

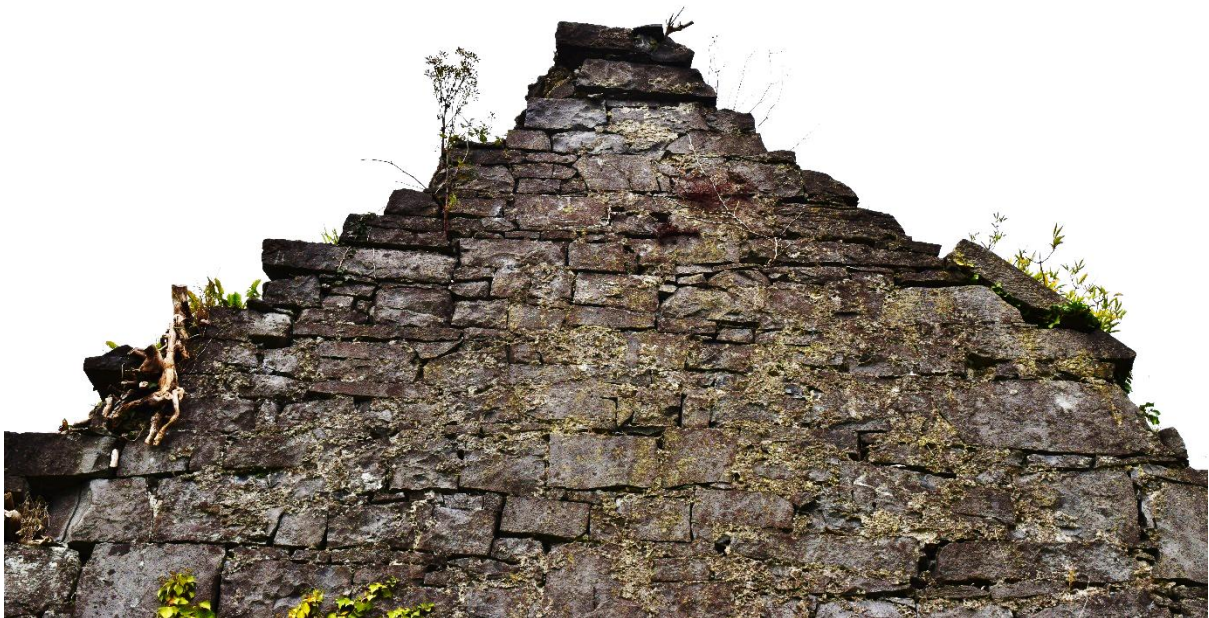
Plate 20 View of the East Gable (exterior): coping has been lost with only two pieces remaining.

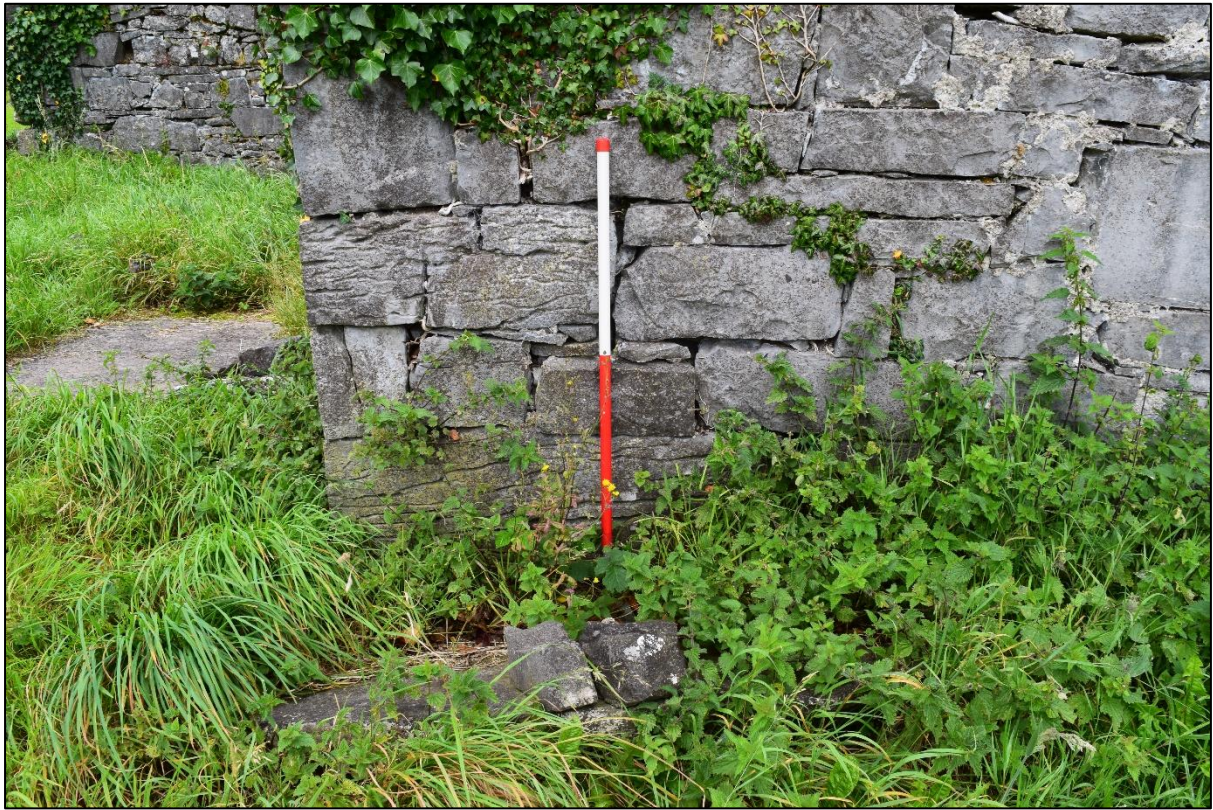
**Plate 21** East elevation exterior: fallen masonry, carved coping stones may be part of the architectural fragments on the ground

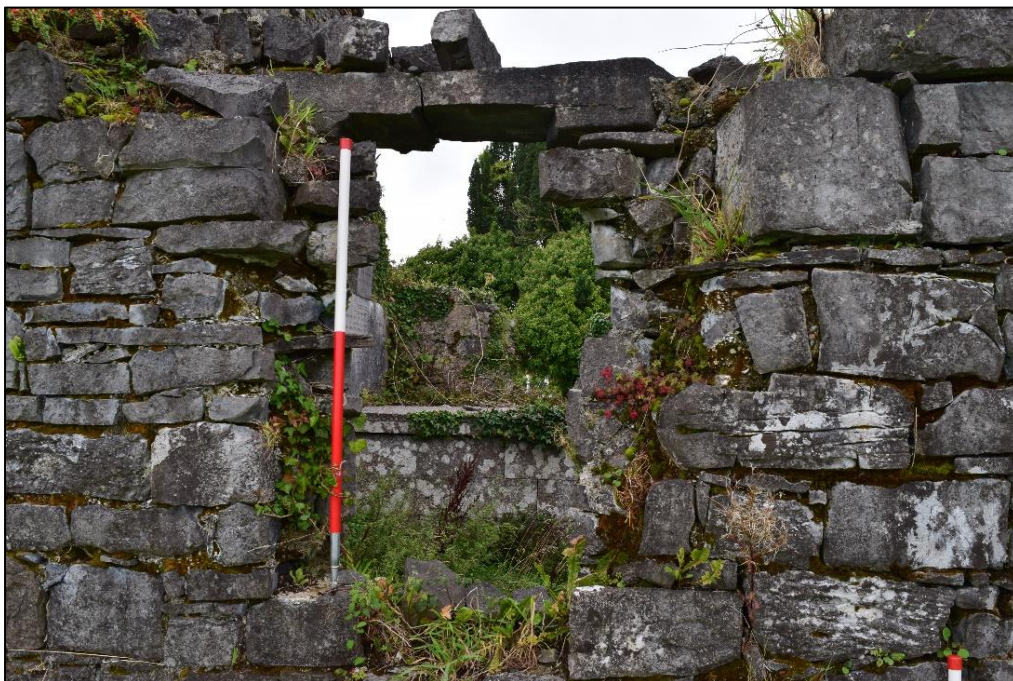
The overall condition may be graded as fair, with critical deterioration concentrated at the north wall lintel which is cracked and upper masonry zones where there is a mild spalling risk.

Plate 30: North elevation, window surround has been lost. Cracked lintel requires conservative repair as per Sketch B (Appendix 4)

### ***7.1.4 Essential Repairs to the Lintel on the North Wall***

The medieval limestone lintel on the north wall is severely deteriorated and at risk of collapse. Although it carries minimal structural loads, a durable and concealed repair is required.

Three 12 mm diameter threaded rods shall be tapped, fitted and welded into a 5mm thick × 150mm wide stainless-steel plate positioned beneath the lintel. These fixings are mechanically secured without resin and grouted in lime using a colour-matched lime-based repair mortar.

The stainless-steel plate will be concealed below with a lime-based repair mortar reinforced with stainless-steel mesh. Above, bolt heads and washers will be covered with a lime-based mortar flaunching (NHL 3.5), designed to shed water and protect the lintel from future deterioration.

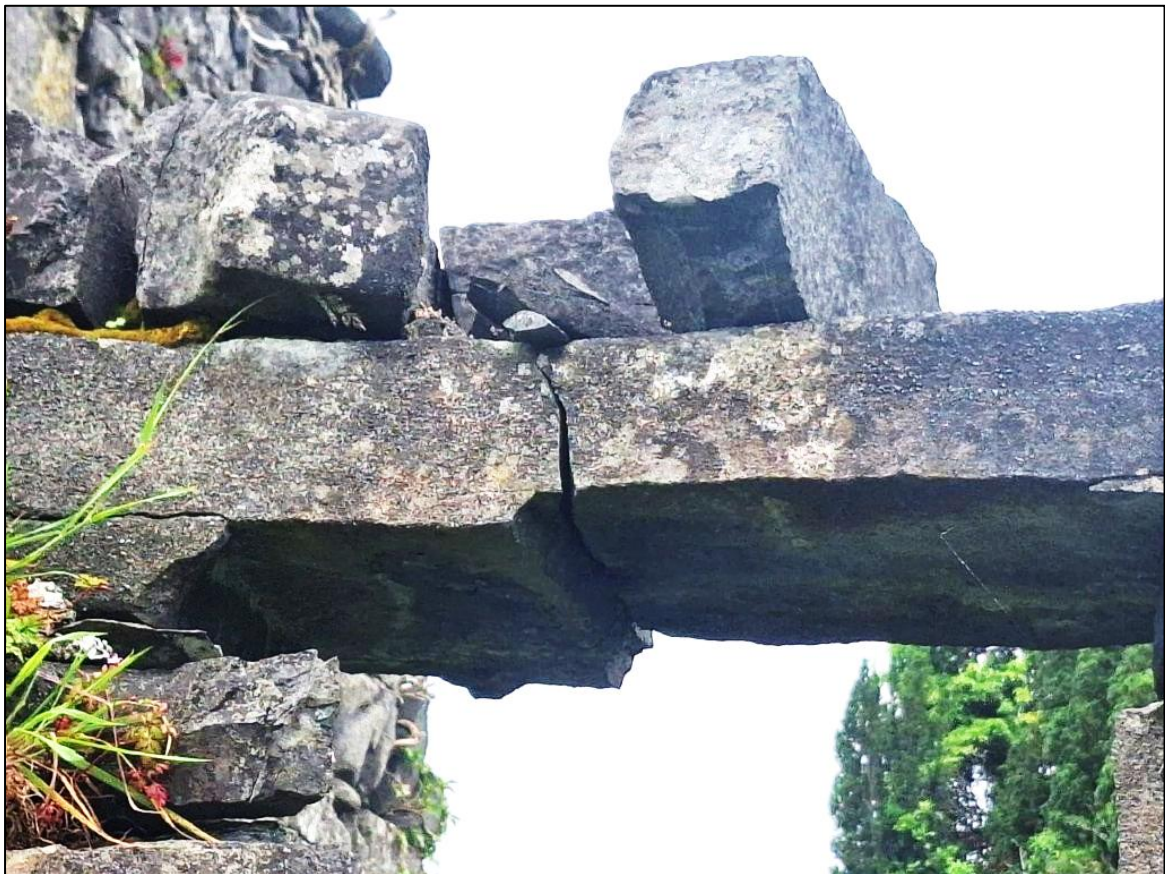
Plate 31: Detail of crack in lintel.

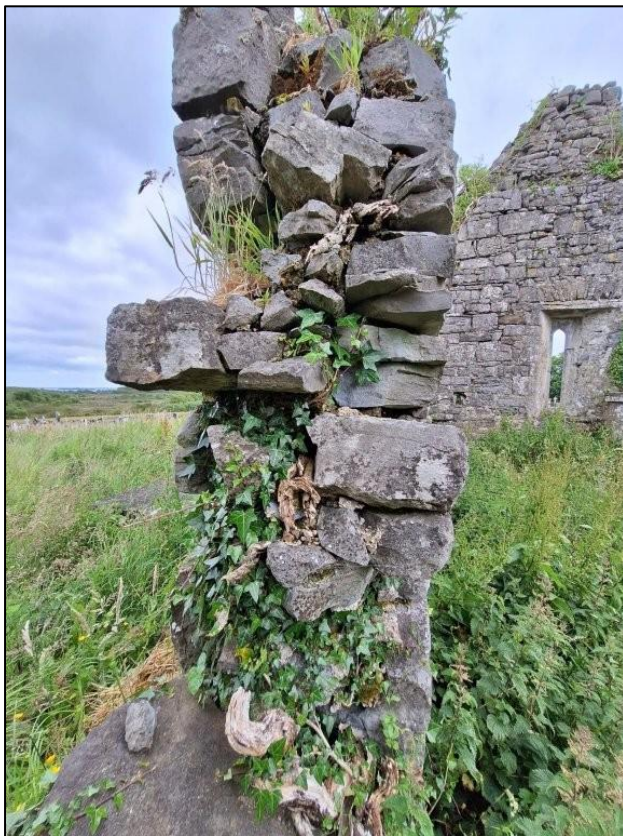
Despite this, the structure is under threat of spalling at the top of the walls and active deterioration due to ivy growth concentrated along the upper masonry. Ivy—whether bedded in at the top of the walls or at ground level—poses a structural risk through root action and mechanical displacement, particularly where it has penetrated joints or bedding planes of the masonry. Following vegetation management, a competent mortar coping will be required to consolidate the wall heads and prevent further loss of material. While not in imminent danger of collapse, the structure presents localised risks—particularly at wall heads—requiring exclusion zones and phased stabilisation.

Plate 34: Typical wall construction with fragile tops and edges requiring consolidation

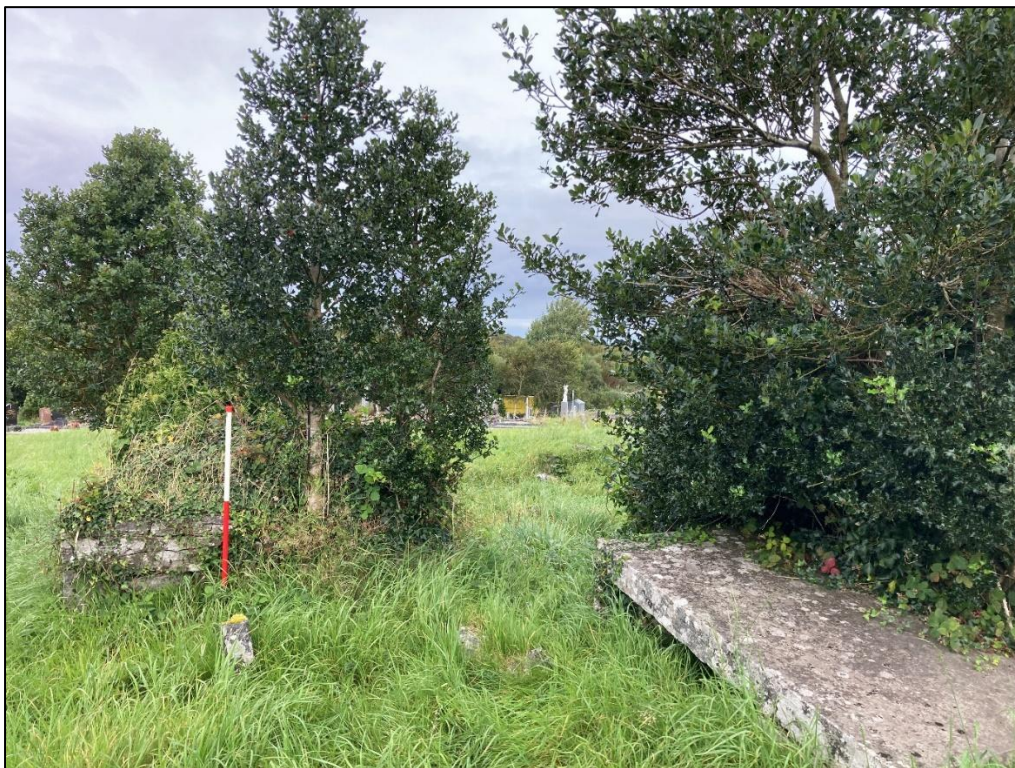
Plate 36: South elevation of nave, west end, masonry has mostly been lost. Appears to have been original point of entry according to 1839 description (see section 4.2.3).

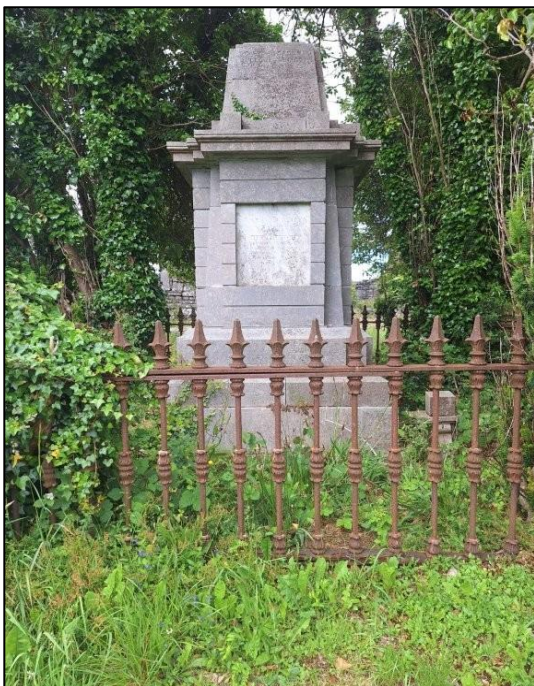
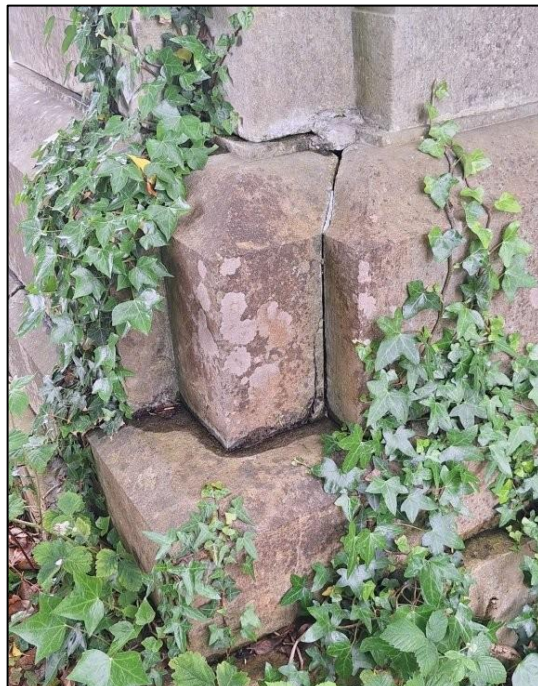
**Plate 40 Memorial requires minor repairs to reinstate capping. Base of missing cross can be found on the ground ready for reinstallation. <maintenance to the railings is advised. This work is incidental to phase1 proposals**

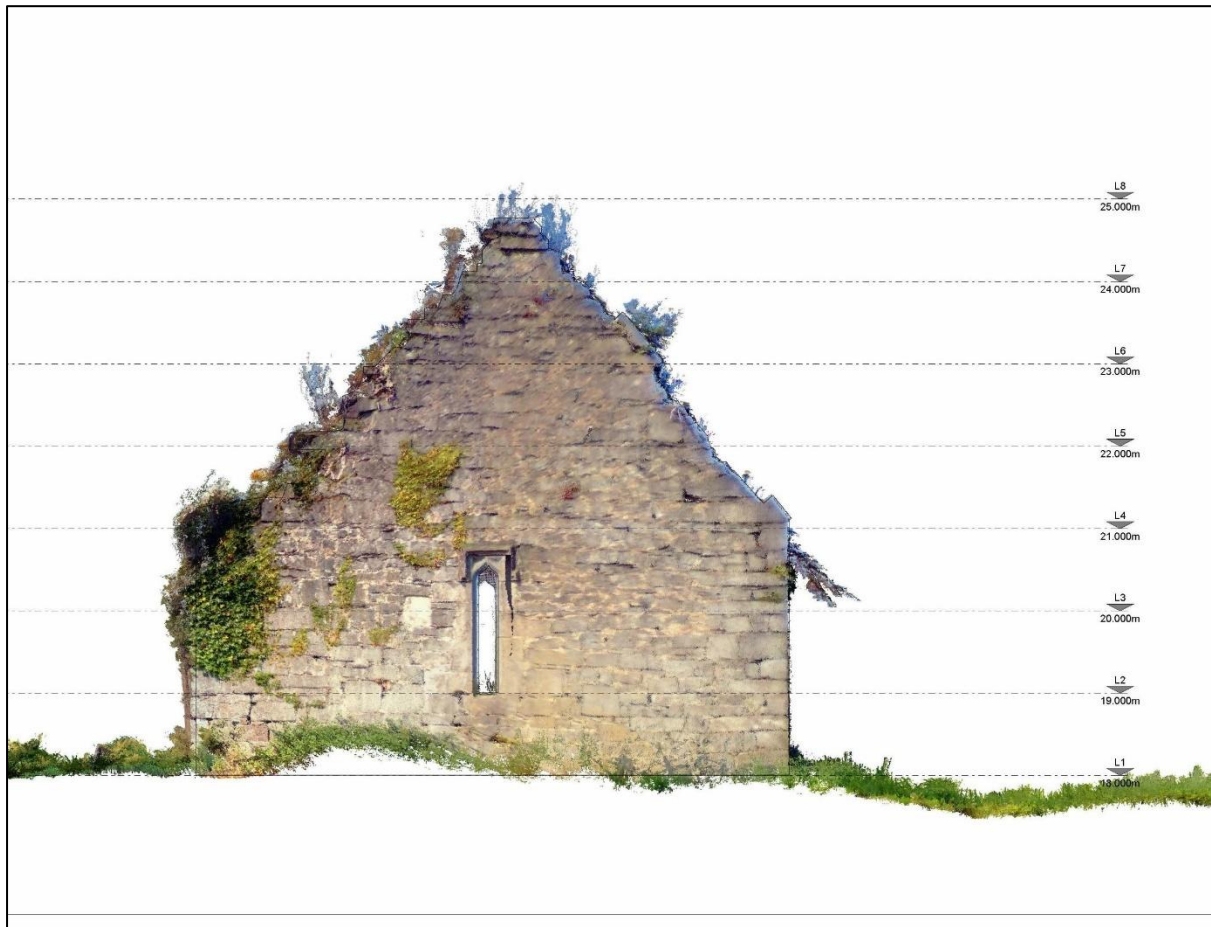
Sketch E: Orthophoto of East Gable wall to be carried out in Phase 1.

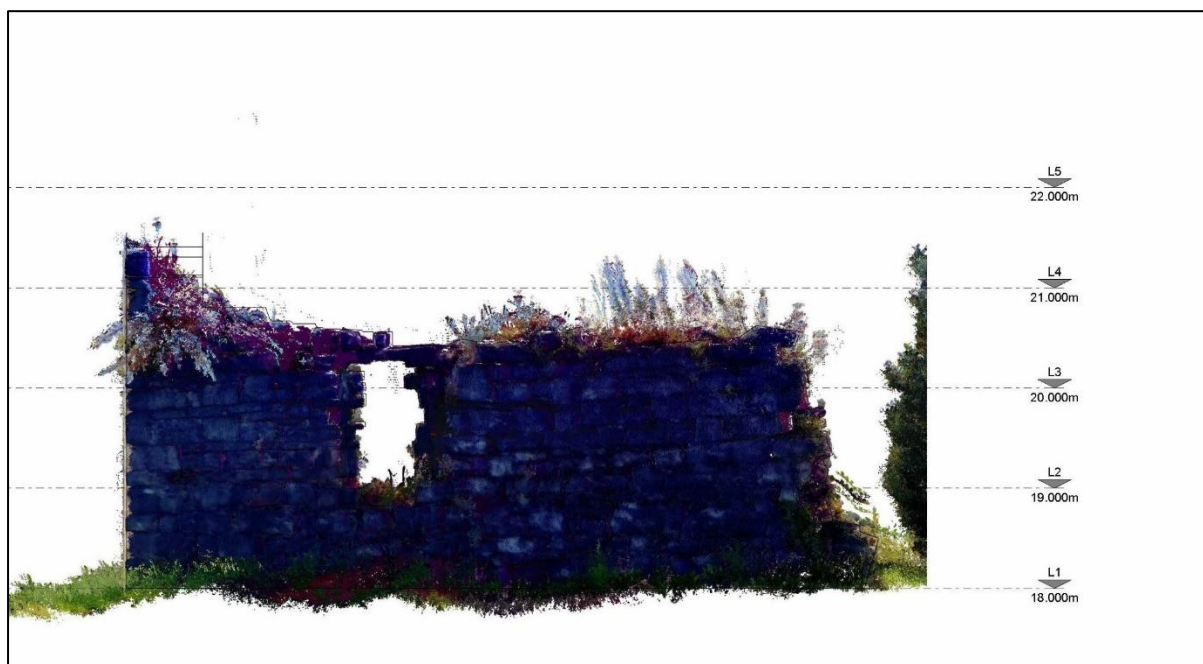
Sketch F: Orthophoto of north wall and lintel, works of which will be carried out in Phase 1.

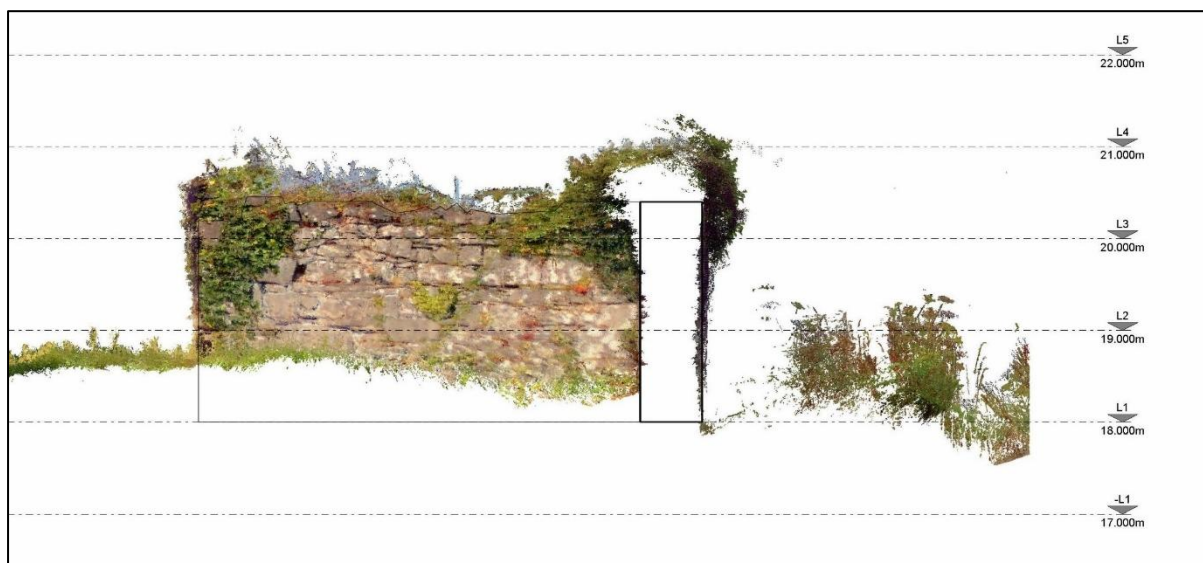
Sketch H: showing east elevation of South Transept. Vegetation treatment to be completed in Phase 1 and masonry works in Phase 2.

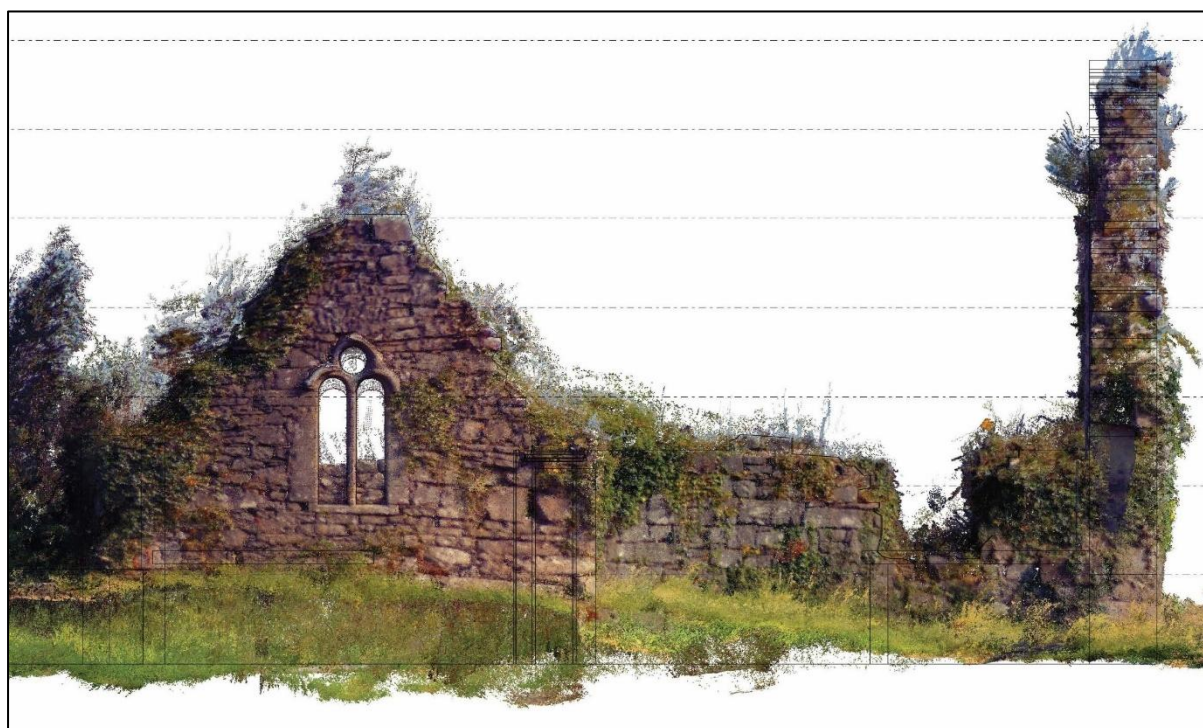
Sketch I: Orthophoto of South Transept gable and south wall of nave. Vegetation treatment to be addressed in phase1 and masonry works in phase 2.

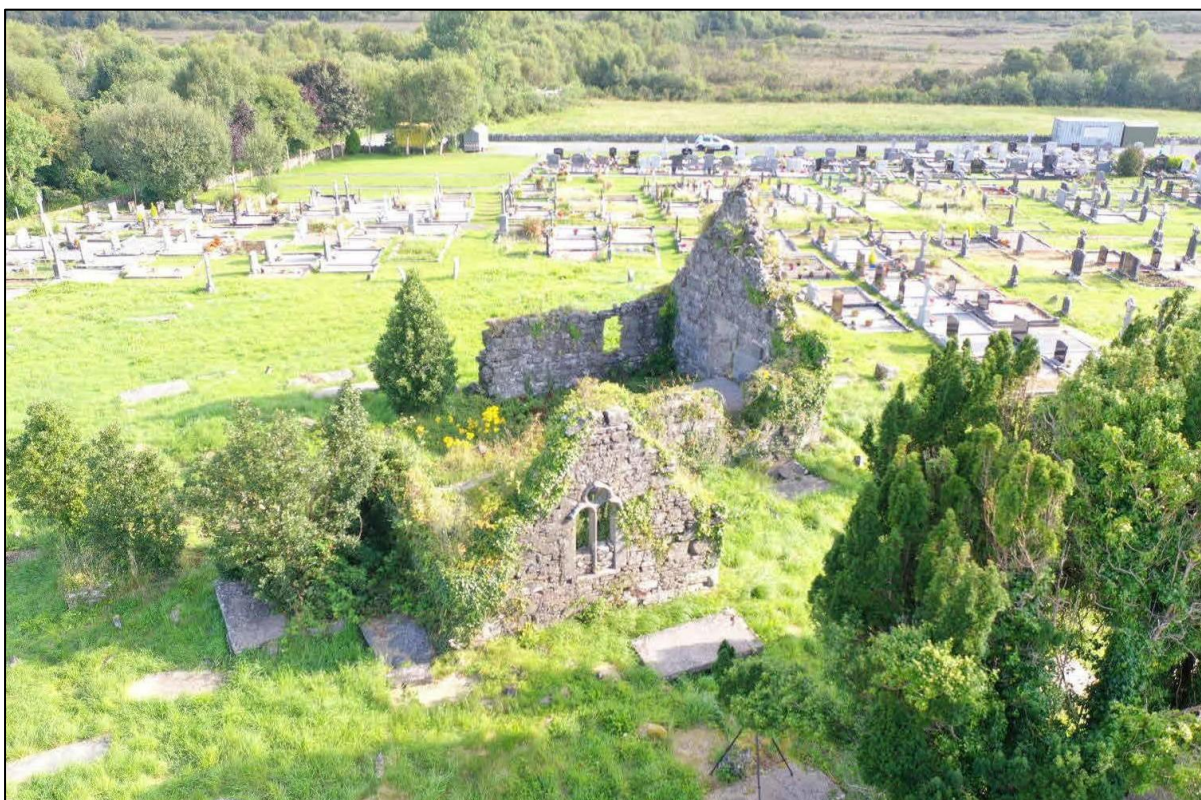
Sketch K: Drone photo facing northeast: South Transept with the west wall overgrown.
